GROUNDING OF SHIELDED CABLES

INSTA-LINK[®] - CLIX/8

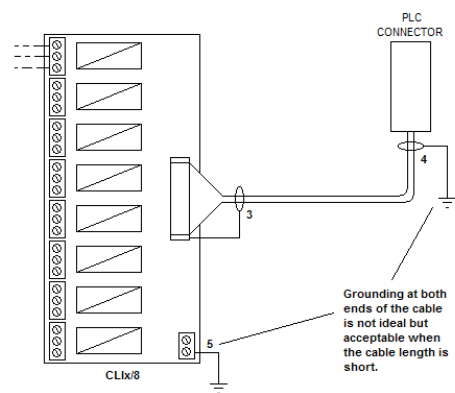
The shield on the cable between the CLIX/8 and the PLC analog input card should be grounded via the CLIX/8 and not grounded at the PLC connector. This is a matter of convenience as many PLC cards do not include provision for shield grounding. Having said that, it is likely that the CLIX/8 is installed in close proximity to the PLC (within the same control cabinet for example) so a ground loop between the CLIX/8 and the PLC is very unlikely. Because of this grounding the cable at both ends should not cause a problem.

Figure 3 - Grounding cables at multiples points within a control cabinet is not ideal but should not cause a ground loop.
